Introduction

In November 2007 Rail Corp Quarry was approached to trial the BIRN VTP (Ventilated Turbo Pulley) Pulleys at their Bombo Site. The choice of plant to trial the range was on their secondary crushing plant where some of the most extreme conditions were found. The particular plant chosen was a Jaques 4ft Cone Crusher. This crusher was fitted with a 475mm 8spc VTP pulley on the drive, and an 800mm 8spc VTP pulley on the crusher.

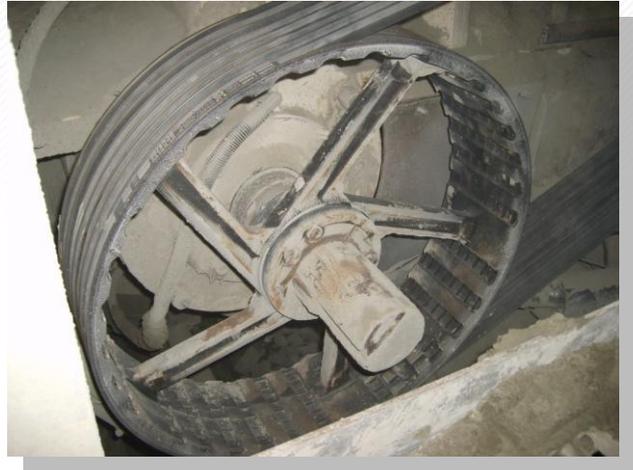
In December 2007 the crusher pulleys were changed to the BIRN VTP style. These pulleys are at the time of our audit, (December 08) still in operation and not due for replacement until mid next year.

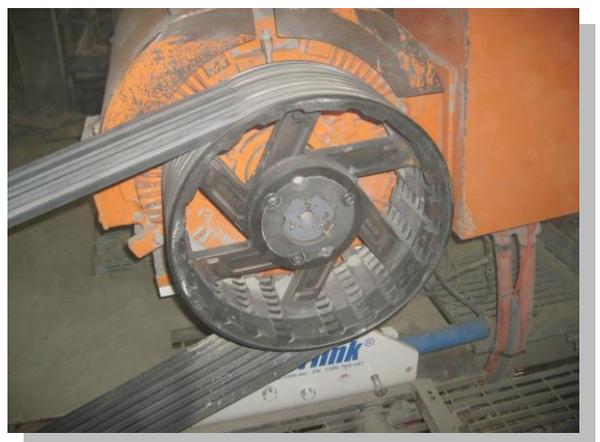
The trial proved the VTP style pulleys were able to work within the extreme conditions without failing.

The dust build up on the inner circumference was all but eliminated with cleaning not required so far. Also the wear in the grooves caused by the dust build up was lowered as proven in the length of service life.

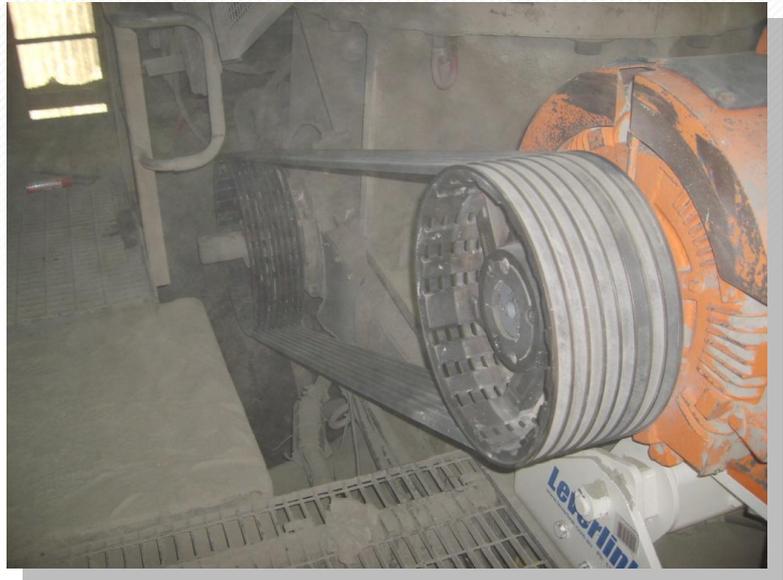
This should be a subject all on its own. As anyone connected with industry will know OH&S is a very real issue for business to deal with. Using the VTP had some significant advantages. As you can see from the photographs in the document, access to the crusher pulley is somewhat difficult. As the VTP pulleys are much lighter (50% to 60%) than grey iron pulleys, the installation of the VTP was much safer and easier. The 800 8spc VTP – 8 groove pulleys at 77.5 kg is safely lifted by two men, grey iron for this size range is app 168kg.

NB. The guarding for the pulleys has been removed for the photographs in this document.
